Resistance of Exterior Walls to High Velocity Projectiles

Prepared by
The Canadian Masonry Research Institute

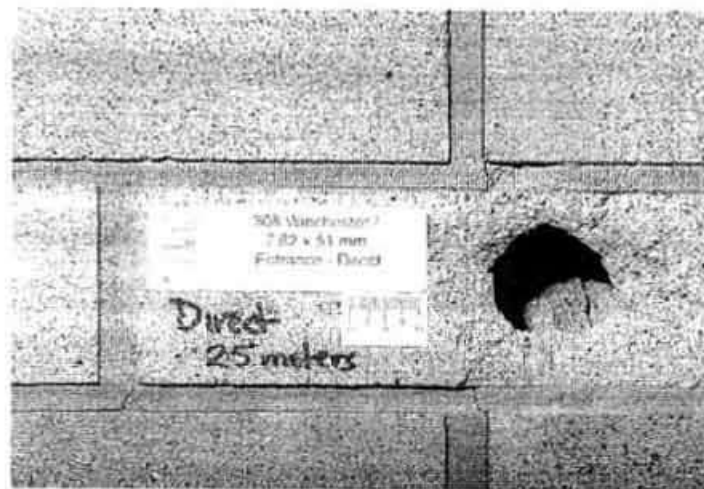
The .308 Winchester bullet produced removed a chip approximate 80 mm wide by 55 mm high from the brick. In addition, a 35 mm diameter hole was produced to a depth of about two thirds the brick thickness. The mortar was cracked around the perimeter of the brick.

Figure 3 - Damage to clay brick caused by .308 Winchester

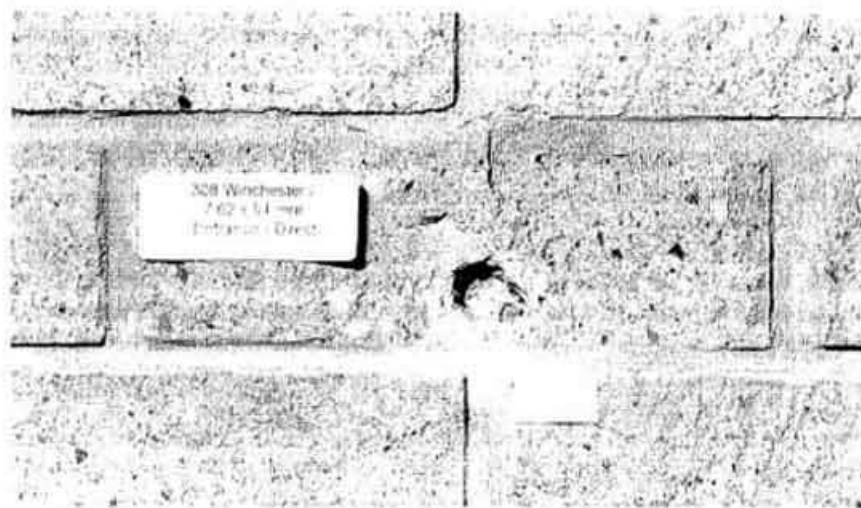
The .308 Winchester bullet removed a region approximately 100 mm wide by 55 mm high. The hole was 25 mm by 20 mm to a depth of approximately half the brick thickness. This damage is shown in Figure 4.

Figure 4 - Damage to concrete brick caused by .308 Winchester

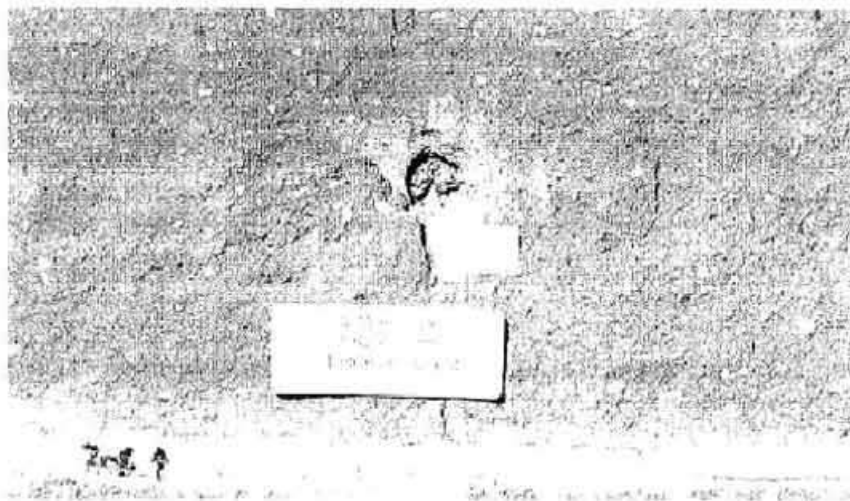
The .308 Winchester bullet displaced a portion of the block approximately 40 mm in diameter. It left a hole approximately 21 mm in diameter and 13 deep as shown in Figure 5. The brick was also cracked from top to bottom with the fracture plane running through the hole.

Figure 5 - Damage to red concrete brick caused by .308 Winchester
